DTE 03-17

Commonwealth Electric Company

Annual Service Quality Report

Year Ending December 31, 2002

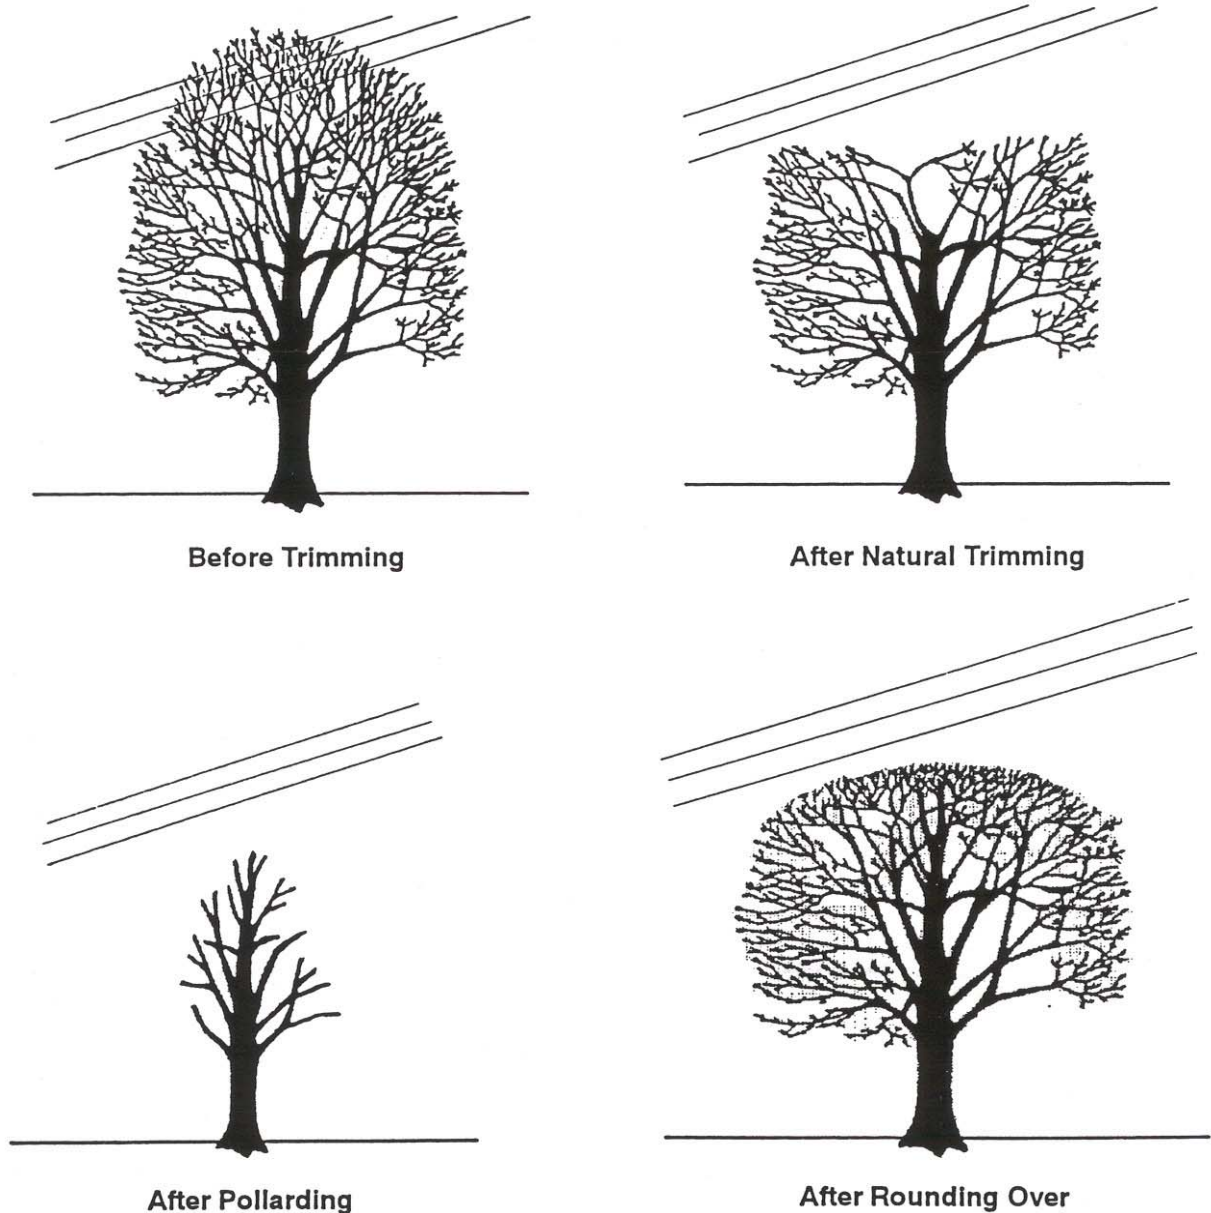
Figure 3. Basic Trimming Methods

There are many methods of pruning trees for line clearance, but not all methods are attractive or advantageous to the tree, nor are all methods effective for long-term line clearance. The basic pruning methods are pollarding, shearing or rounding over and natural pruning (Fig. 3).

Stubbing off major limbs by pollarding is not a desirable pruning practice.

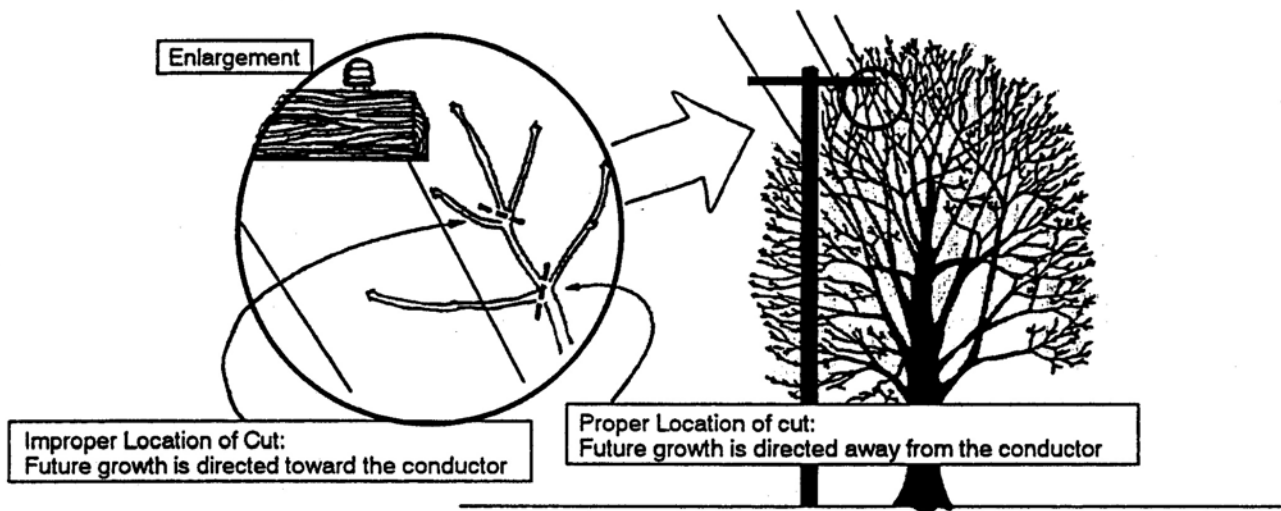
Figure 4. Natural Trimming (to direct growth away from wires)

Natural Pruning is the method recommended by most professionals. Natural pruning is cutting branches flush at a suitable parent limb, back toward the center of the tree. This method of pruning is sometimes called “drop crutching” or “lateral pruning”. An attempt is made to remove large branches to laterals at least one-third the diameter of the branch being removed. All cuts should be flush to avoid leaving stubs. Natural pruning is especially adapted to the topping of large trees where a great deal of wood must be removed. In natural pruning, most cuts are made on larger limbs with a saw, and little pole prune work is required. The results are natural-looking trees, even if large amounts of wood have been removed. Natural pruning is also directional pruning, since it tends to guide the growth of the tree away from the wires (Figure 4). Stubbing, on the other hand, tends to promote rapid sucker growth right back into the conductors.

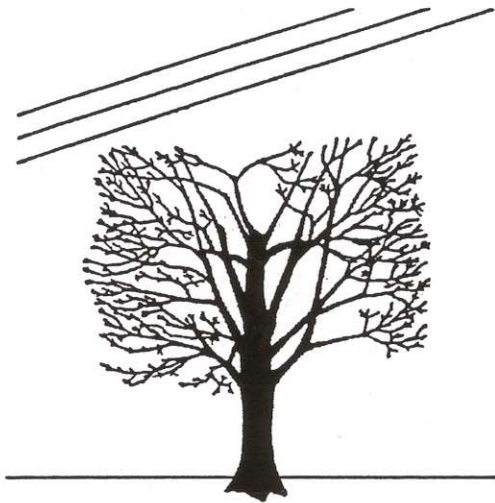
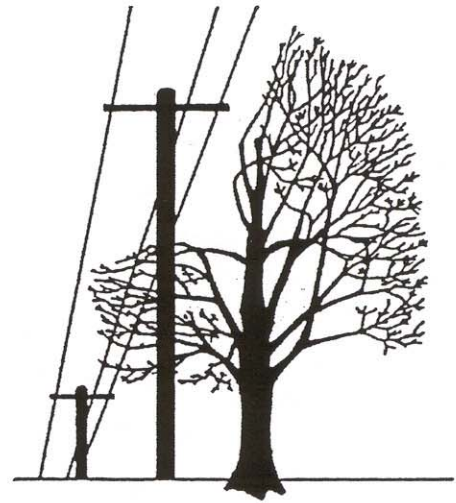
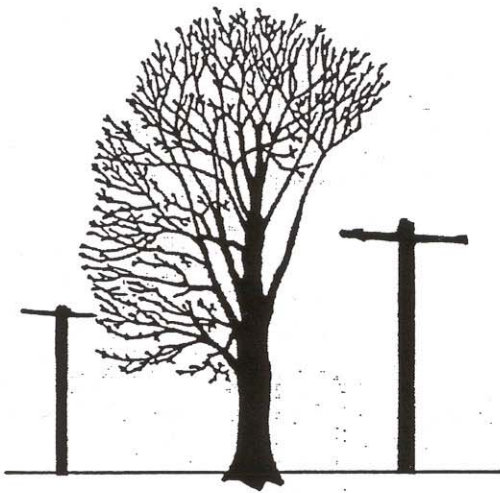
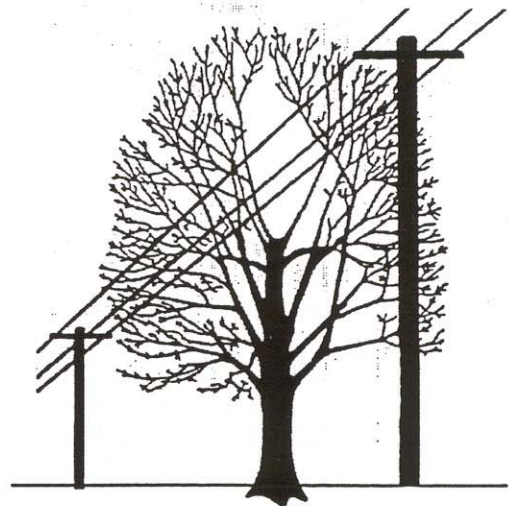
Figure 5. Four types of natural trimming.

Crown Reduction is cutting back portions of the upper crown of a tree. Reducing is indicated when a tree is located directly beneath a line. The main leader or leaders are cut back to a lateral, which should be at least one-third the diameter of the limb being removed. Most cuts should be made with a saw. A pole pruner is used only to cut lateral branches. To minimize re-growth, no more than one-fourth of the crown should be removed when topping (Figure 5).

Side Trimming is cutting back or removing side branches that threaten the conductors. Side trimming is required where trees are growing adjacent to utility lines. Limbs should be removed at a lateral branch. Notches in tree crowns should be avoided, if possible. Shortening branches above and below the indented area, or balancing the opposite side of the crown, will usually improve the appearance of the tree. When trimming, all dead branches over the wires must be removed, since this dead wood could easily break off and cause an interruption in service (Figure 5).

Overhang Or Under Pruning consists of removing limbs beneath the tree crown to allow wires to pass below the tree crown. This type of pruning will allow the tree to retain its natural shape and continue its normal growth. Overhangs are hazards when lines pass beneath a tree and should be removed according to the species of the tree, location and the general policy of the utility. When pruning, all dead branches above the wires are removed, since this dead wood could easily break off and cause an interruption. Many utilities have a set removal program for trees that overhang important lines (Figure 5).

Through Pruning is the removal of branches within the crown to allow lines to pass through the tree. It is best suited for secondaries, streetlight circuits, and cables, although it is often used on primary circuits where there is no other way of pruning the tree. Cuts should be made at crotches to encourage growth away from the lines (Figure 5).

After Top Trimming

After Side Trimming

After Under Trimming

After Through Trimming

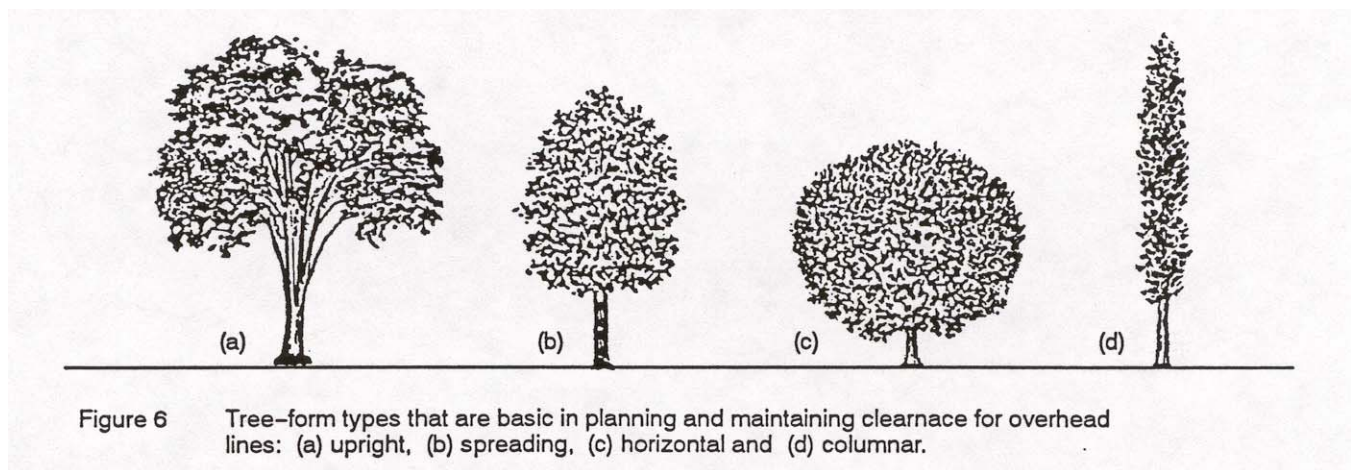
Before tree trimmers begin work, they plan how they are going to trim each tree. Consideration is given to how and when a tree is going to re-grow after it is trimmed. Trees can usually be placed into one of four tree-form types: upright, spreading, horizontal or columnar (Figure 6). If possible, the natural form of the tree should be maintained so that it does not look heavily trimmed.

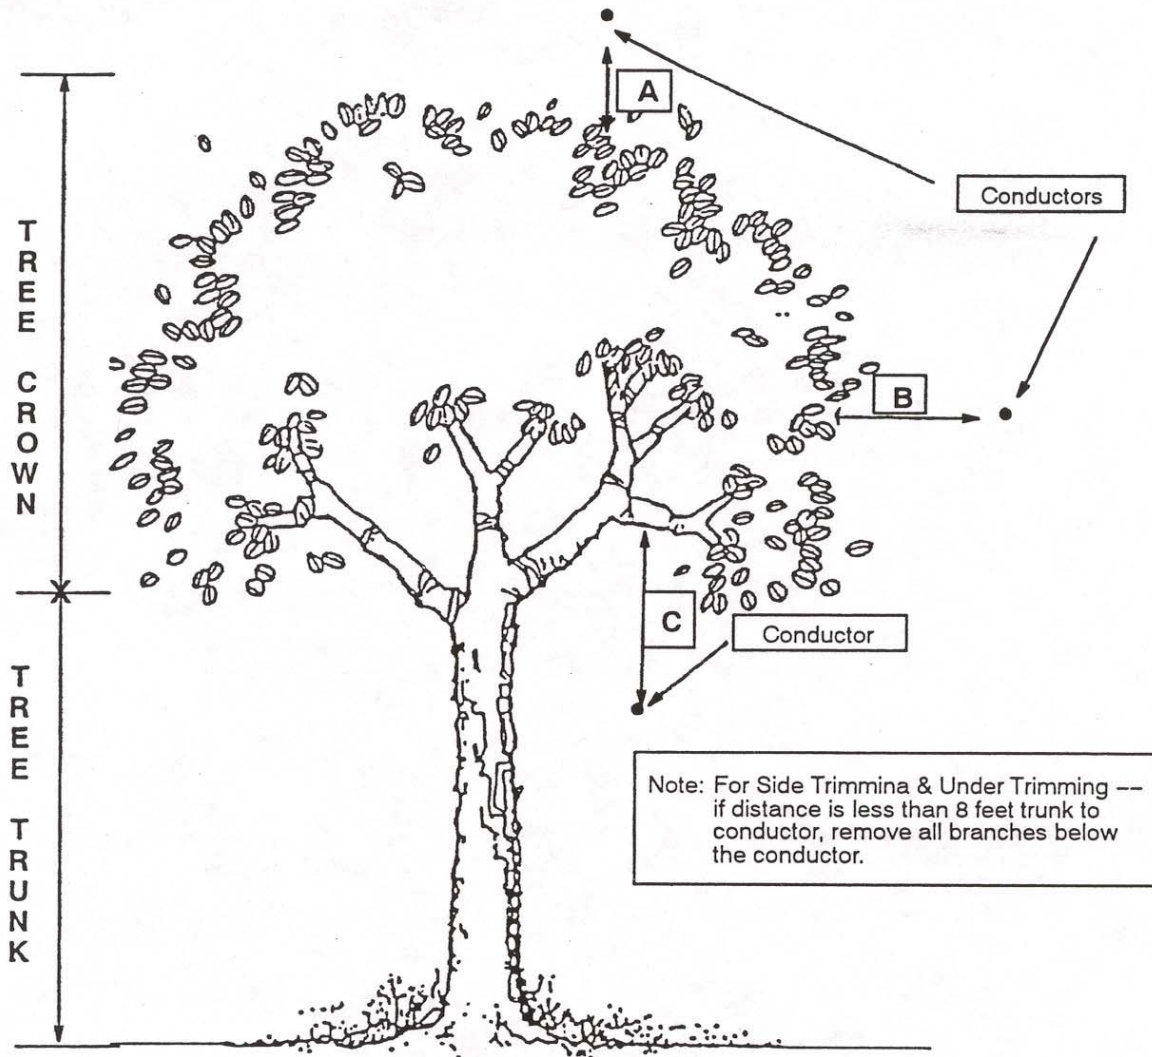
EXHIBIT 1

Note: Our objective is to obtain trim clearances as indicated. However, extenuating circumstances may dictate that lesser clearances be accepted.

CLEARANCE	TYPE OF TRIMMING	MINIMUM CLEARANCE FOR 25 KV OR BELOW *
"A"	Topping	8 Feet
"B"	Side Trimming	8 Feet
"C"	Under Trimming (Remove overhang situations where possible)	12 Feet **
